October 10, 2016

# ADA Transition Plan

## City of Ridgecrest

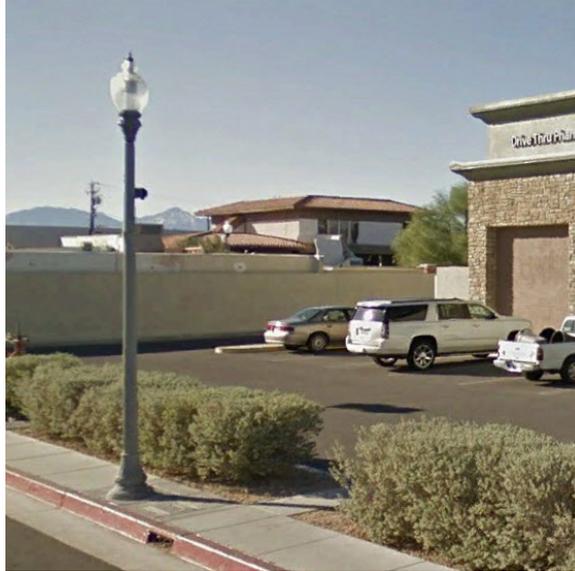
RIDGECREST BLVD. WEST OF CHINA LAKE BLVD

Other obstacles to ADA access were noted. Street light poles on Ridgecrest Blvd. west of China Lake Blvd. have been installed in the sidewalk, posing obstacles to people in wheelchairs. One such location is shown in the photograph below.

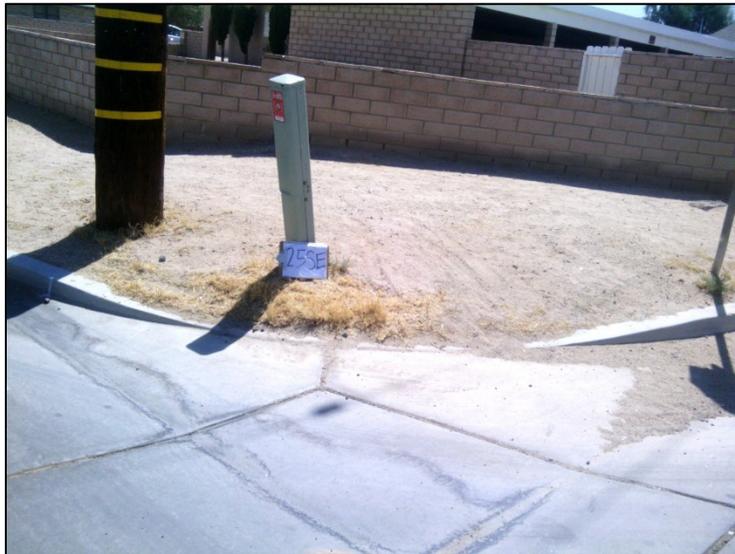
SOUTHEAST CORNER OF SUNSET ST. AND CHURCH AVE.

In a few locations it was found that other items such as utility cabinets, power poles or traffic signal poles may create obstacles to people in wheelchairs. For example, a communications equipment cabinet was noted on the southeast corner of Sunset St. and Church Ave. It would likely need to be relocated to allow construction of an access ramp at that location. However, this location is not currently on an accessible route: there is currently no sidewalk at this location, so there is no requirement to construct a curb ramp here at the present time. Please see the photograph below.

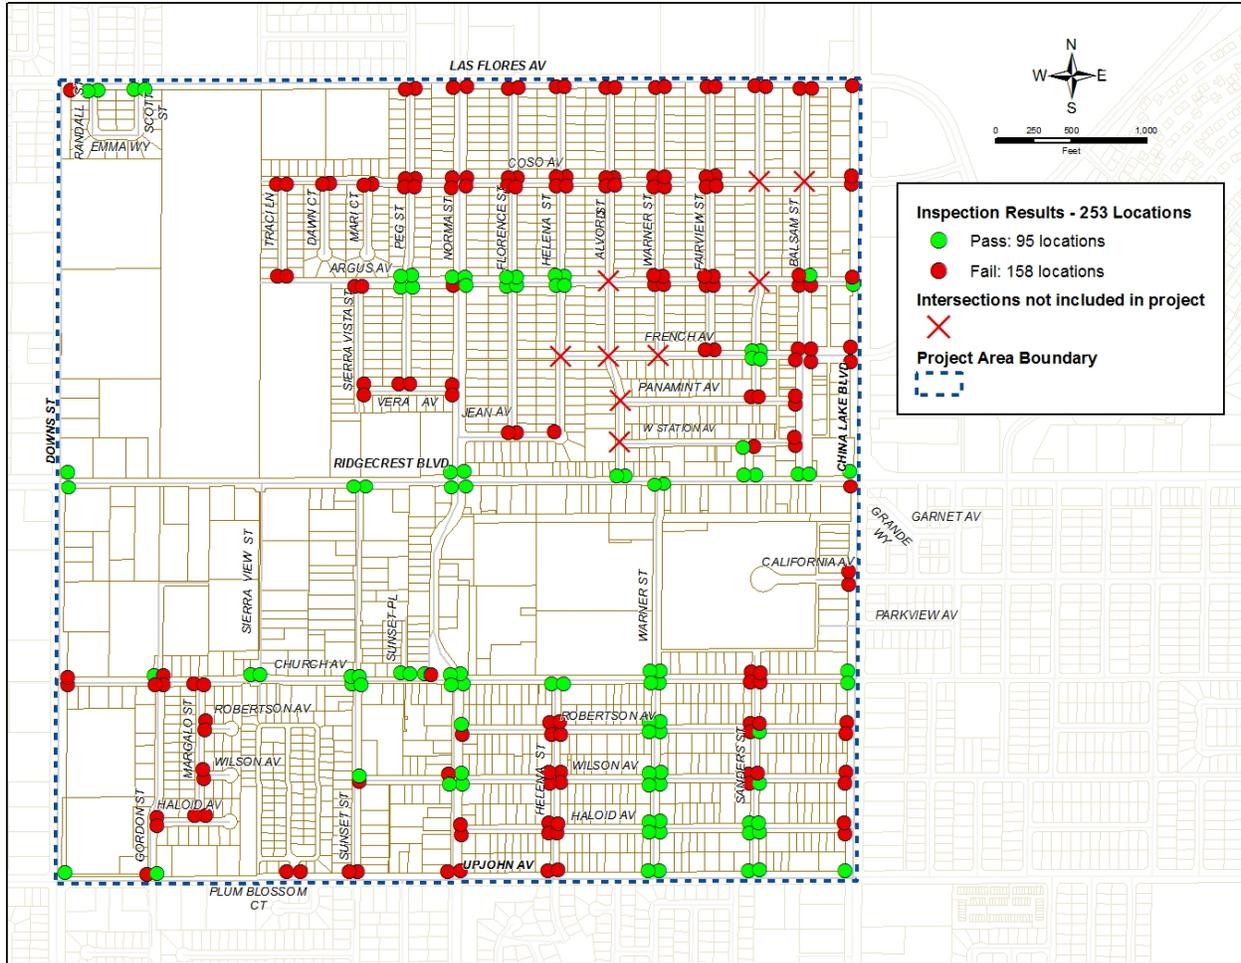
CURB RAMP INSPECTION RESULTS: PASS/FAIL

Of the 253 intersection corners included in this project, 95 locations passed the inspection and 158 locations failed the inspection. The following figure depicts those results by location.

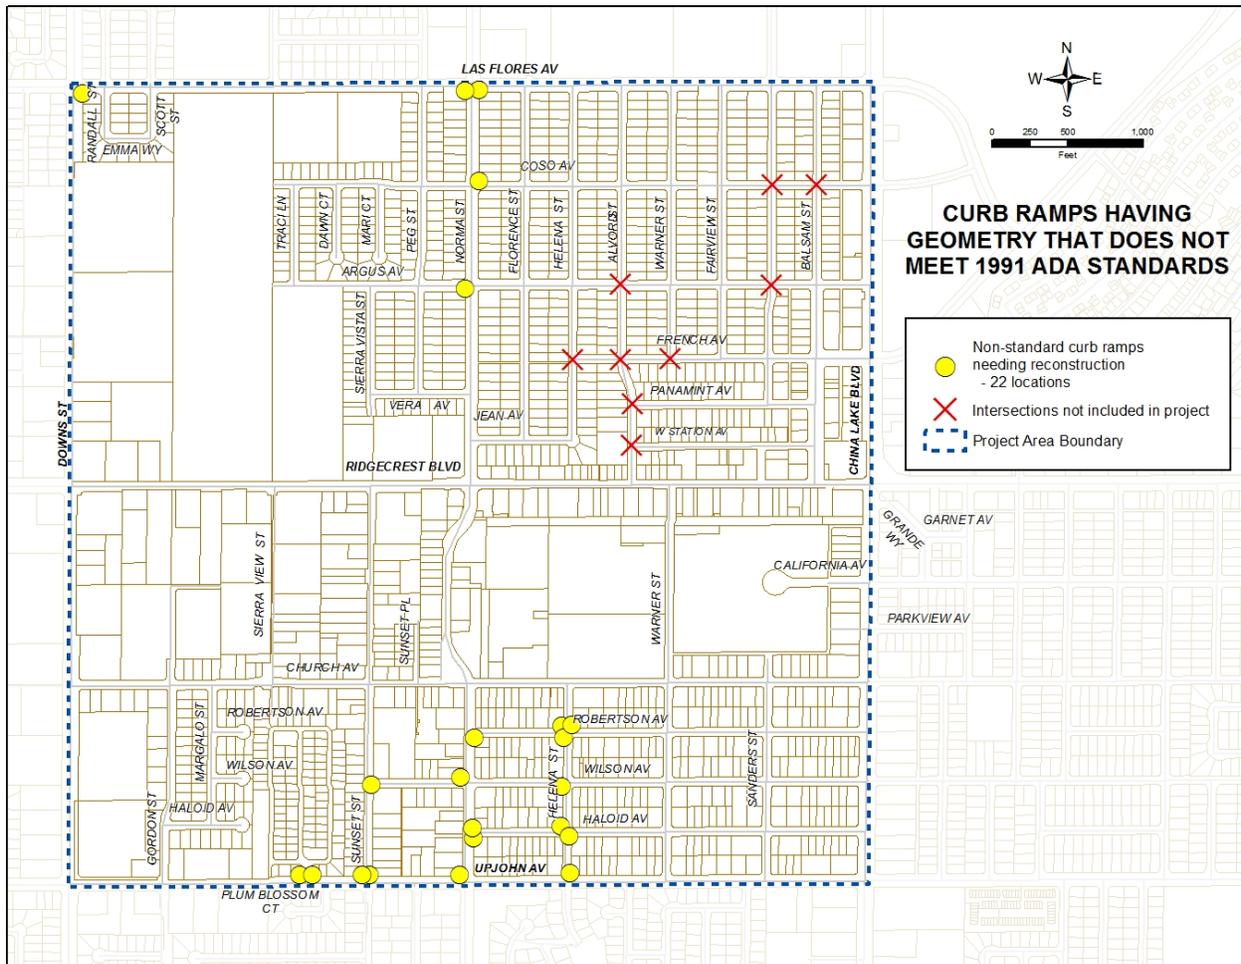
The map below depicts the locations of existing curb ramps that need to be reconstructed to meet the 1991 ADA standards.

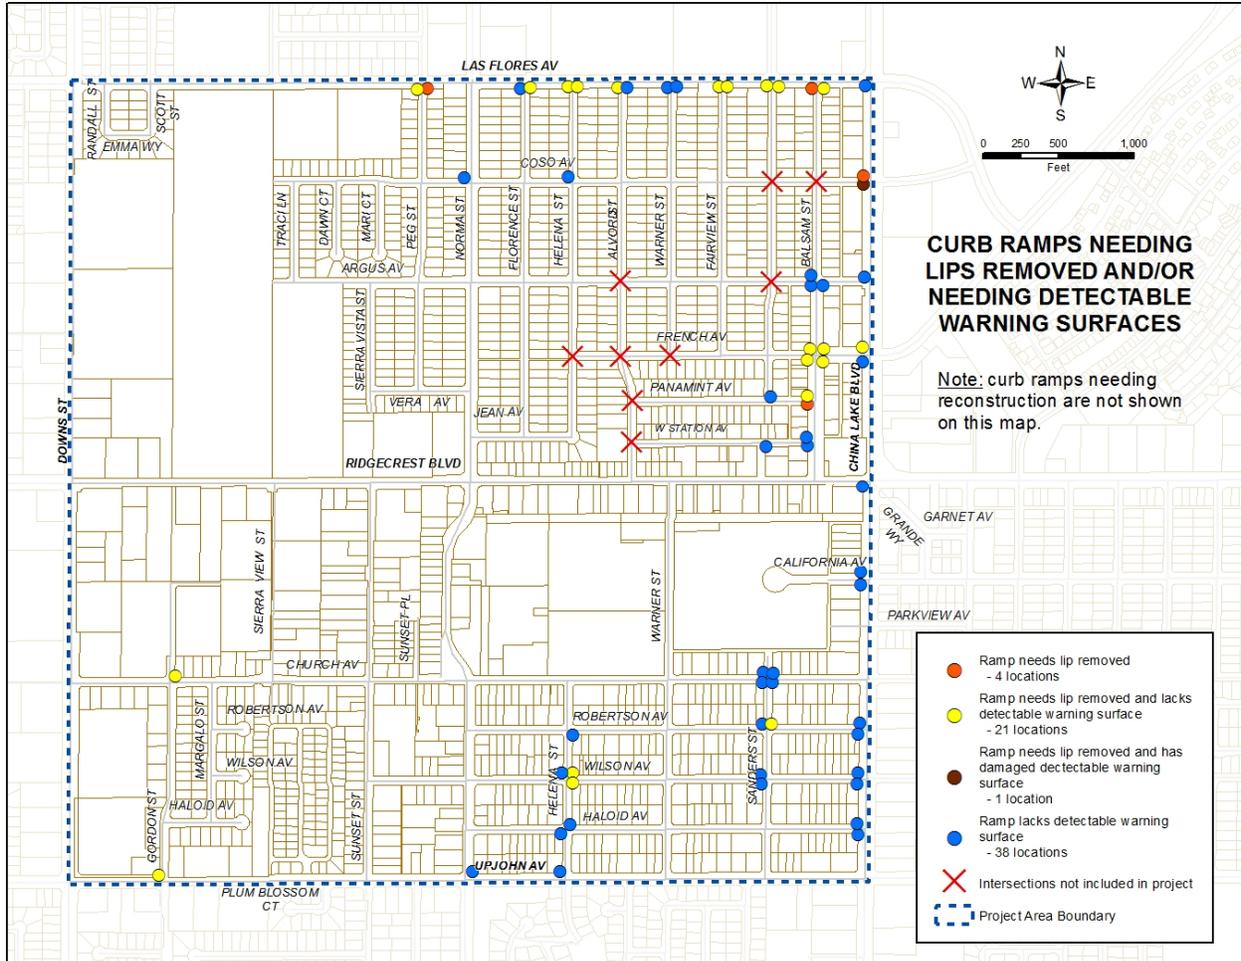
The following map depicts curb ramps with dimensions and slopes that comply with standards, but have lips that need to be removed, lack a detectable warning surface, or have a damaged detectable warning surface.

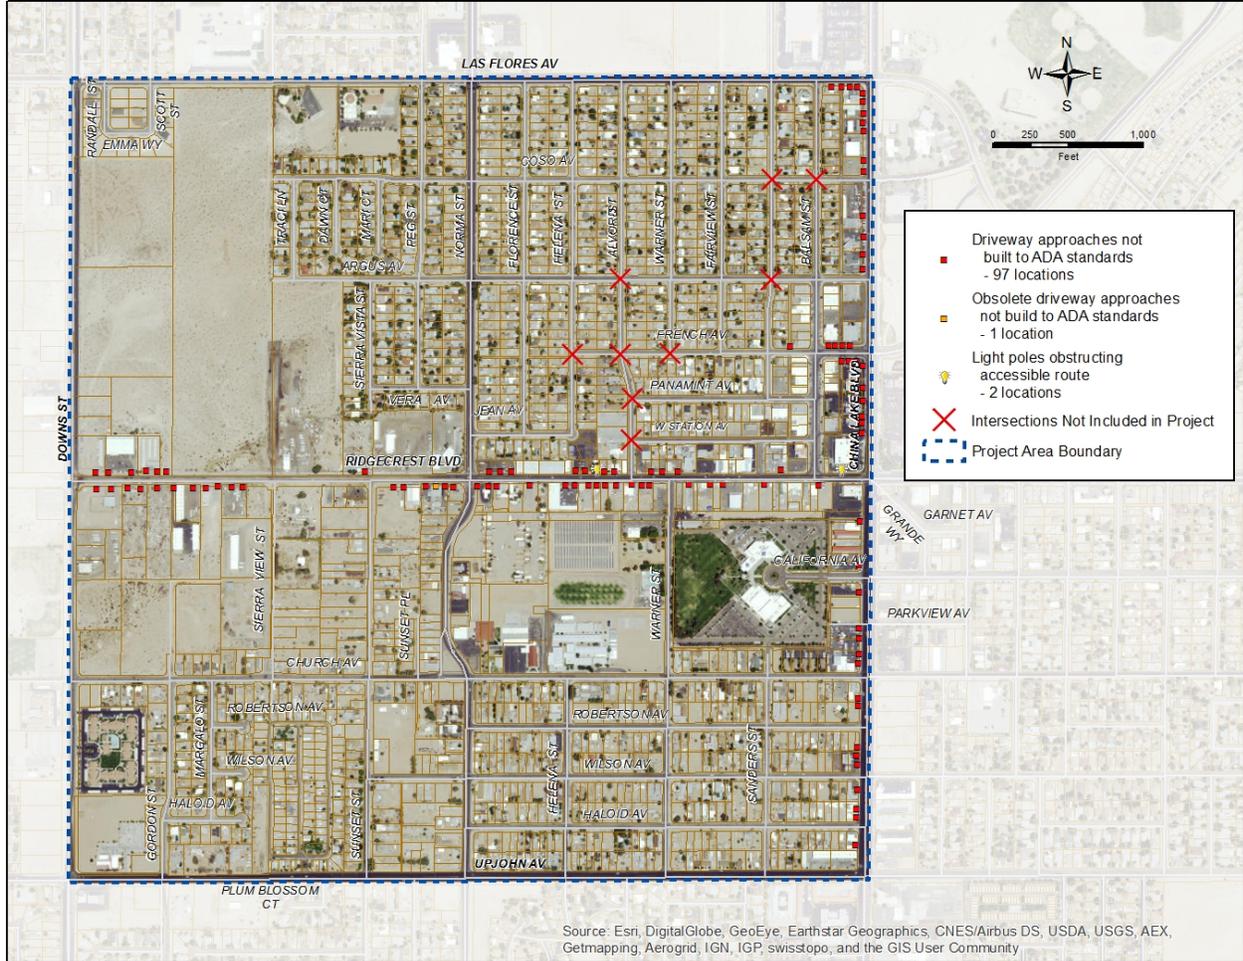
Two light poles were also noted on the north side of Ridgecrest Blvd. that appear to obstruct the accessible route. One light pole is about 160 feet west of China Lake Blvd. The other is located about 200 feet west of Alvord St.

The following figure illustrates the locations of driveway approaches that appear not to have been constructed to ADA standards. The locations of 2 light poles that appear to obstruct the accessible route are also shown.

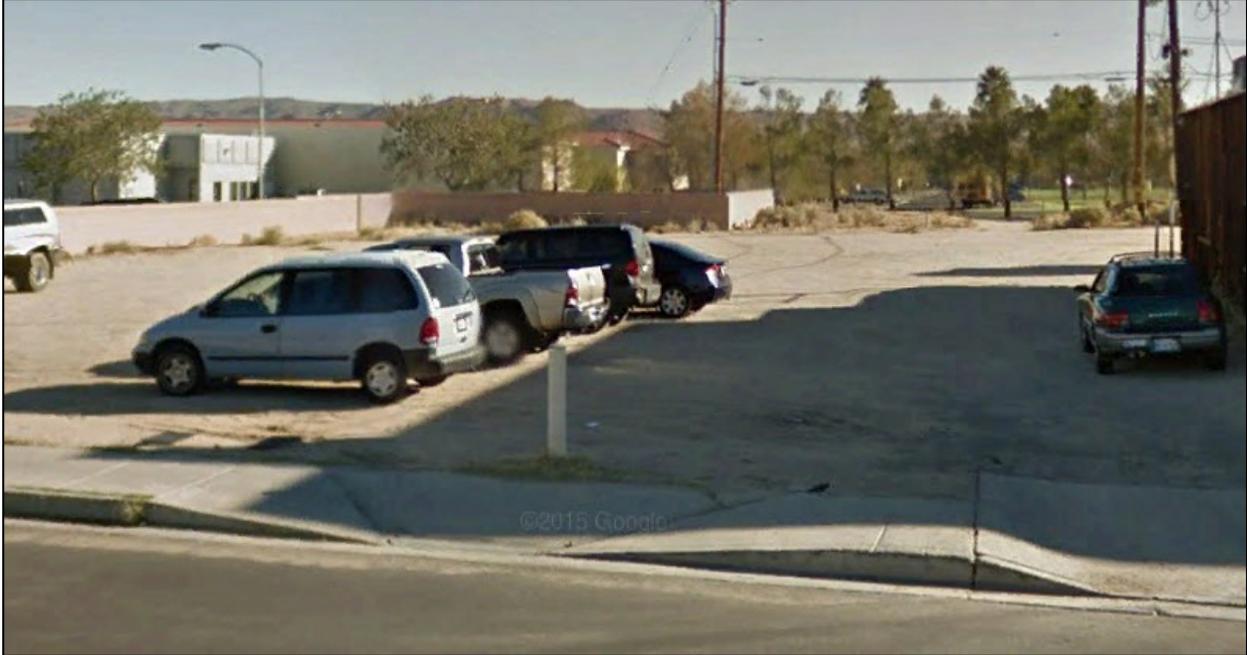
There appears to be an obsolete ADA ramp on the south side of Ridgecrest Blvd. about 270 feet east of China Lake Blvd. The ramp is in front of a vacant lot. A pylon appears to block ingress into the vacant lot from the ADA ramp. Although the ramp and wings may conform to ADA standards, the combination of the ramp and the driveway to the immediate west of the ramp appears to pose an unnecessary inconvenience to people in wheelchairs. The photograph below depicts that location.

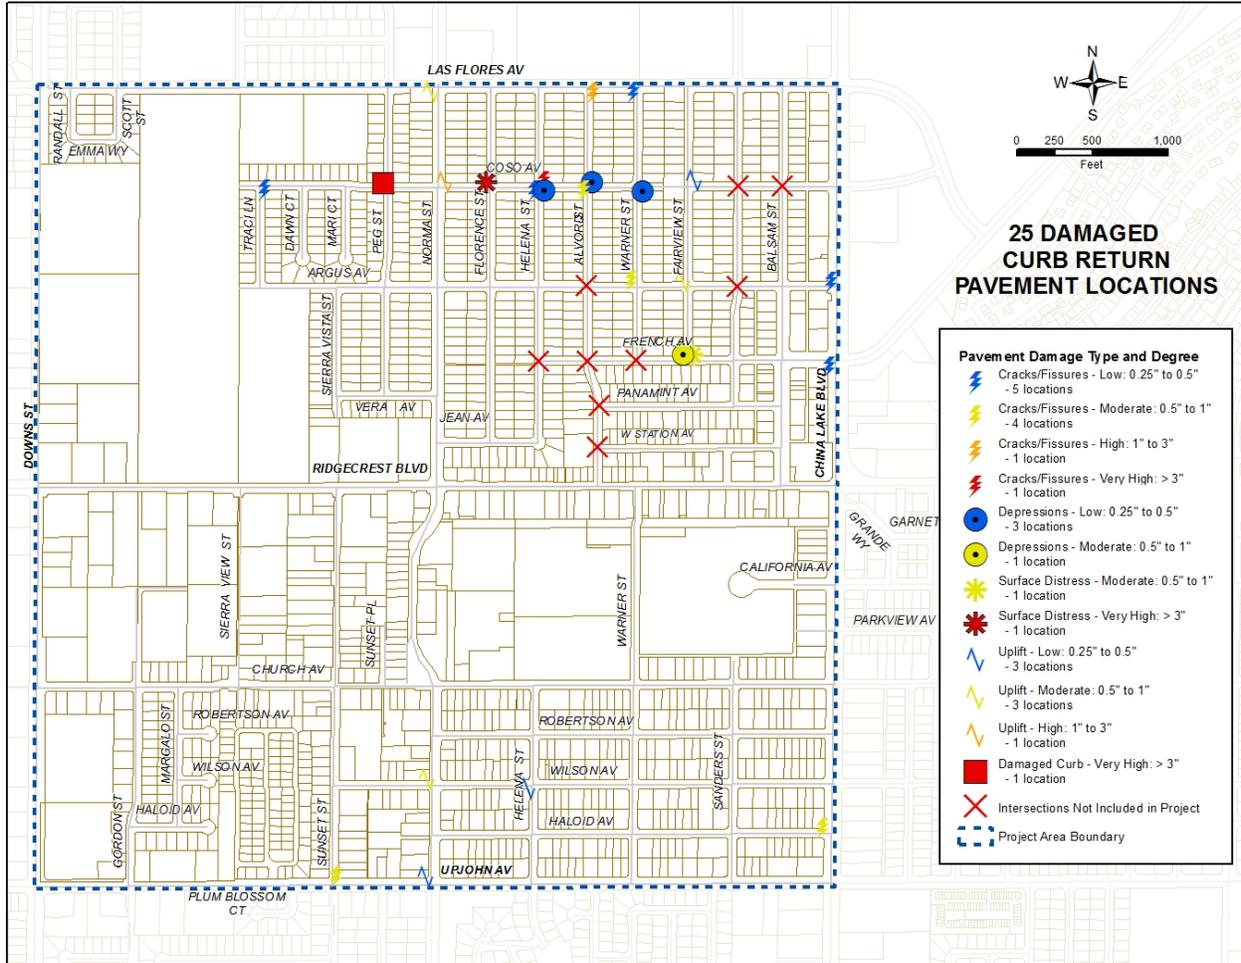
The map below depicts 25 locations of curb returns at which damaged pavement was observed.

Only 6 of these 25 damaged locations are *not* at locations where a curb ramp either needs to be installed, or where an existing curb ramp needs to be reconstructed. The remaining 19 locations will have the damaged pavement repaired when the existing ramp is reconstructed or a new ramp installed.

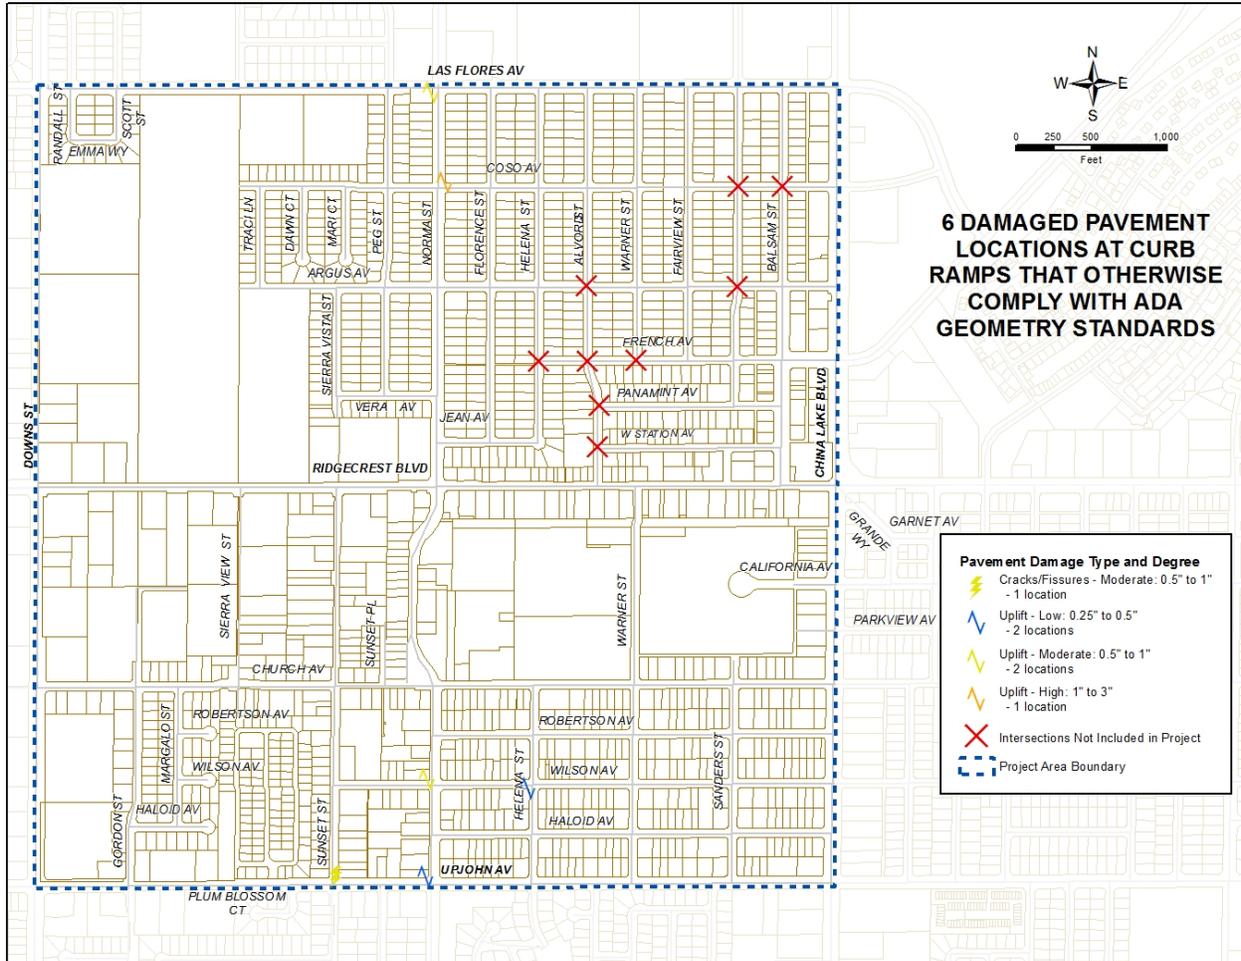
The following figure shows the locations of damaged pavement where the curb ramp may need a lip removed or a detectable warning surface installed, but is otherwise ok.
